INCIDENT REVIEW

3200 Mill Creek Road

A firefighter was seriously burned at a fire in a single-family dwelling

Delaware State Fire School

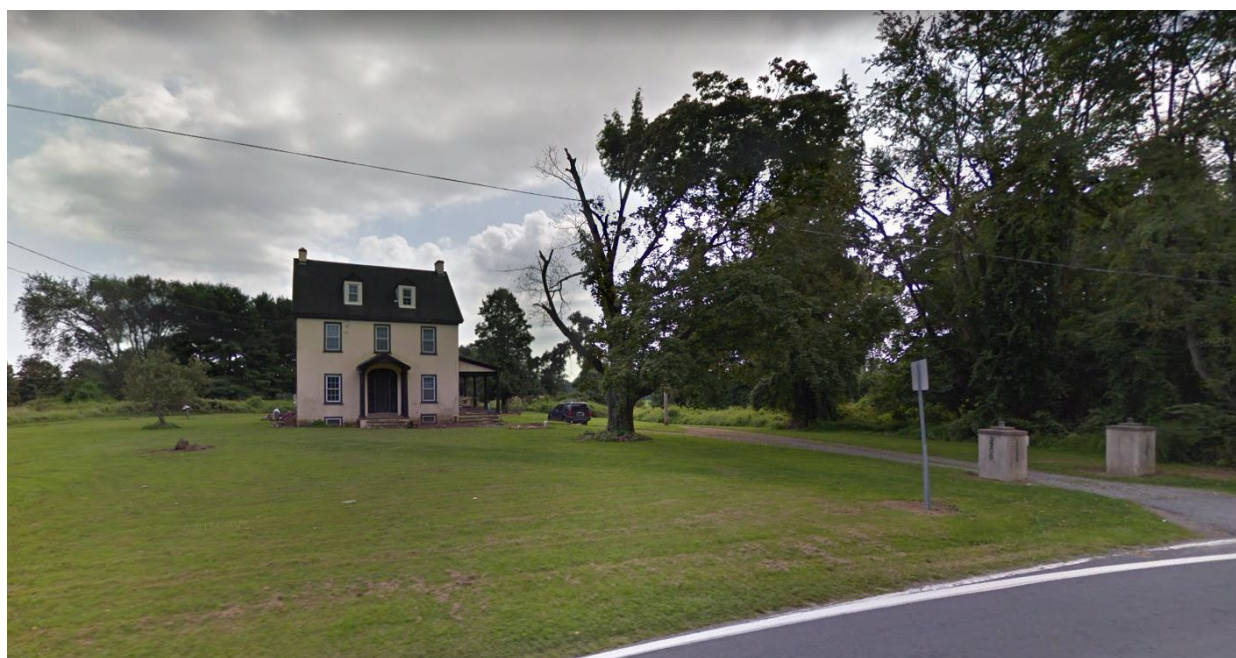
Figure 1-House Before Fire (Google)

The home located at 3200 Mill Creek Road outside of Wilmington, Delaware was built in 1910 according to New Castle County property records. It has approximately 2100 square feet of living space on 2 floors as well as a large attic and a small basement. The exterior walls are masonry with wood joists and flooring. The interior walls are finished with plaster and lathe typical of the era when it was built. The first floor consists of four main rooms, two on either side of a central hallway and stairway. The second floor has four bedrooms (one in each corner) and a bathroom in the center of the front of the house. The stairs continue from the second floor up into the attic. The basement stairs are located under the first floor stairs.

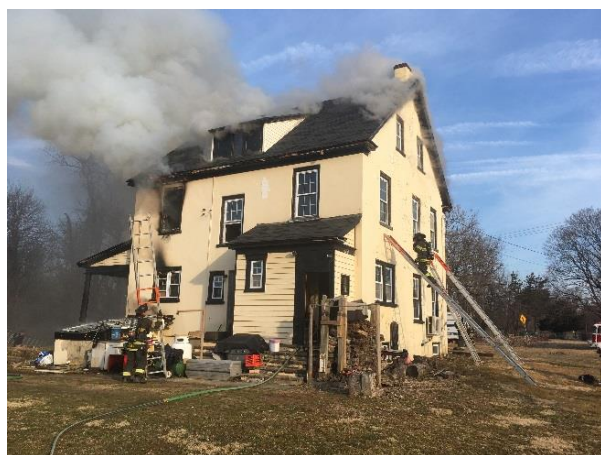
Figure 5-Initial Knockdown (Jankowski)

Ladder 16 had arrived and took the first due special service assignment. Part of the crew began to throw ground ladders and the two entered the structure and followed the hose line and met up with the firefighter from 21-6. One firefighter from Ladder 16 (Rosa) called over the radio for more pressure on the line. Ladder 16 Officer (Games) stated that the hose line did not appear to have good pressure. He straightened a kink and it got better but still not what he would consider adequate. He also called on the radio for more pressure on the line.

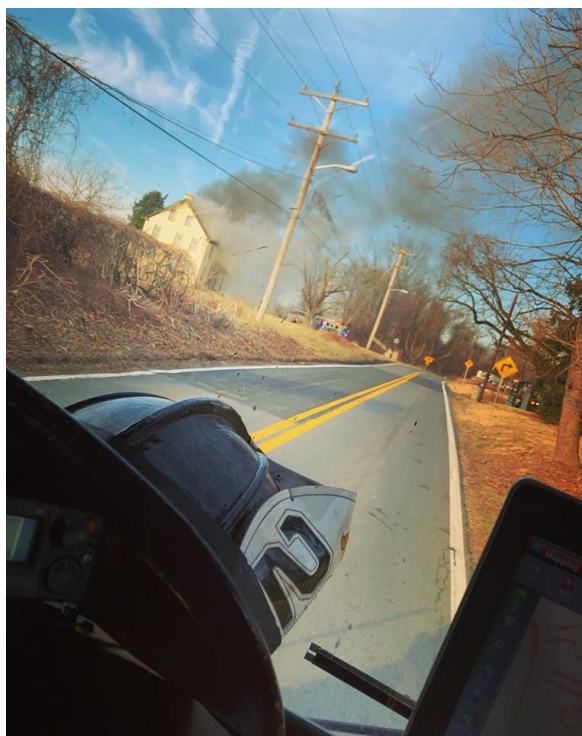
Figure 6-Rescue 23 Arrival (Smiley)

Rescue 23 responded with seven personnel. Two career firefighters, a volunteer Captain, and 4 volunteer firefighters. Squad 23 responded with the Fire Chief (Dierolf, 23-8), a career firefighter driving, and a volunteer firefighter. As Rescue 23 arrived they assumed the second due special service and split their crew. Three firefighters (Asher, Richards, and Colpo) were the outside team. They were given a verbal order from command to ladder the Charlie & Delta sides, which is also their assignment by the county policy. The inside team (Smiley, McKay, Lambert, and Hill) donned SCBA and entered the structure through side Alpha. All had halligan bars with the exception of Lambert, who had a hook and a water extinguisher. They proceeded up the stairs and met up with personnel from Mill Creek and Hockessin with the hose lines. The hose teams advised them that did not have water. They passed those crews and entered the fire room.

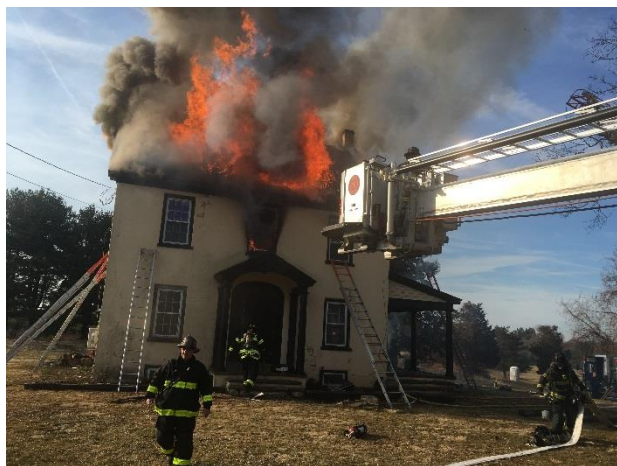
Figure 7-Height of Fire (Jankowski)

A water supply had still not been established at the conclusion of the Mayday. Tanker 19 could not supply 21-6 because all of the lines were hooked to intakes. Chief 19-8 walked over to his tanker as his Captain was walking up from the hydrant. He told the Captain that he needed to get this figured out because 21-6 was out of water. At this point, the Captain disconnected the line coming from the hydrant and hooked it to a discharge. This didn't solve the problem because now the lines were backwards.

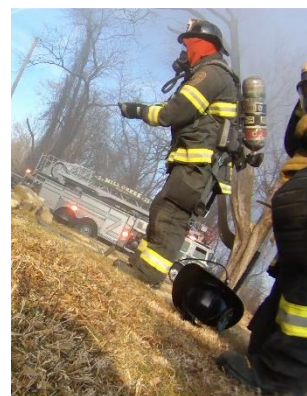
Figure 11-Smileys Just Prior to Entry (McKay)

None of the firefighters from Minquas that could be observed in the video were wearing the waist strap on their SCBA. This appears to have directly led to the difficulty firefighters had in rescuing the injured firefighter. When they attempted to lift him from the hole, they were simply pulling the SCBA from his back.

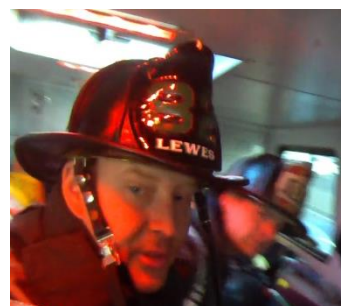
Figure 12-Lewes firefighters on R23

One firefighter riding Elsmere's ladder was wearing his gear from Christiana. One part time firefighter on Hockessin's ambulance was wearing his volunteer gear from Delaware City. Two volunteer firefighters on Minquas's rescue were wearing their volunteer gear from Lewes. This could have caused confusion if they identified themselves on the radio as something other than the gear they were wearing. For example, the firefighter in Christiana gear identified himself as Ladder 16 OV and advised that he was entering a second-floor window. Had

he been the mayday, rescuers on the fire ground would have been looking for a firefighter from Elsmere, not Christiana.

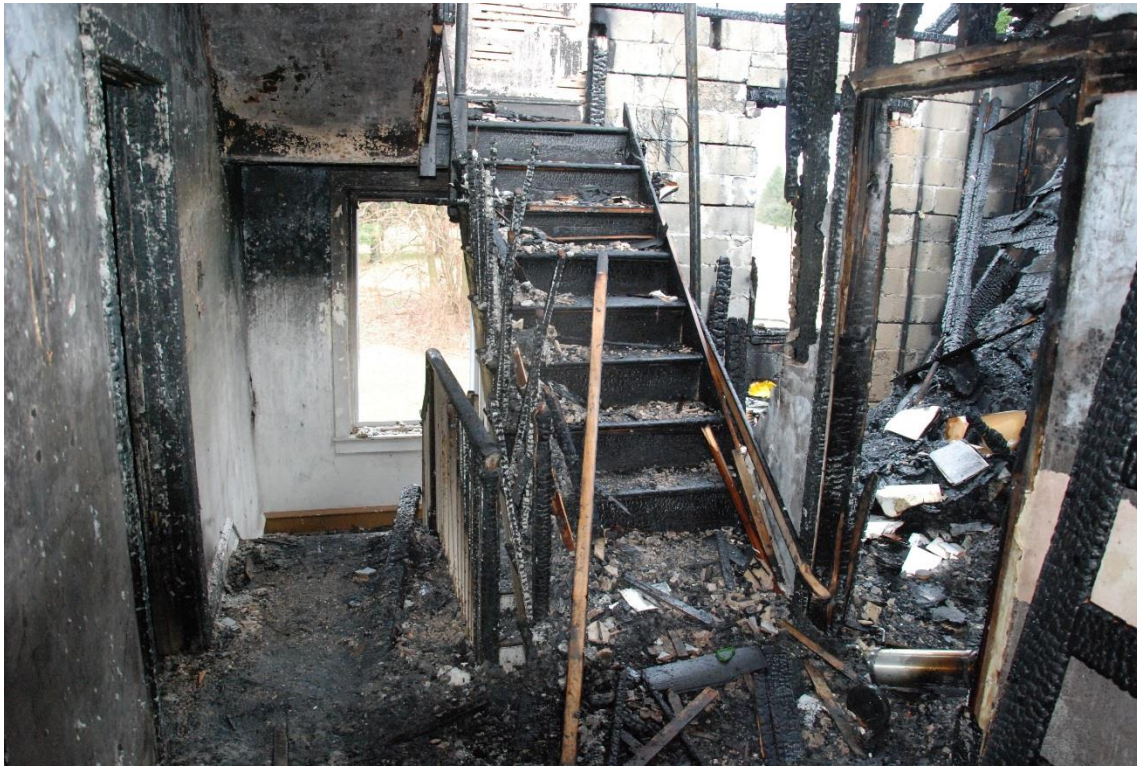
Figure 26-Second Floor Facing Toward Charlie Side (Wilson)

One firefighter stated that he broke a window distal to the fire room “to draw the fire” away from the mayday. This became the only other room on the second floor damaged by fire. Training needs to be provided on fire behavior and how to coordinate ventilation with fire attack.

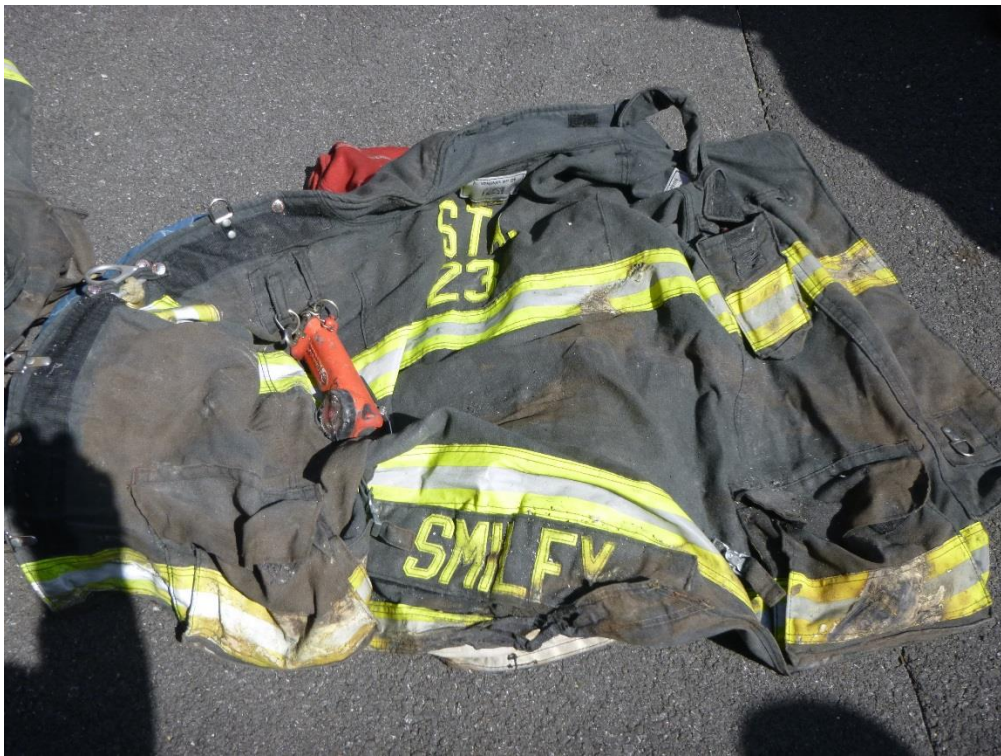
Figure 30-Turnout Coat

As he came through the floor his SCBA pack and his coat came off and he ended up with his right hand stuck in his coat sleeve and his mask dislodged. He was partially hanging by his right arm. A firefighter reported helping him get out of his sleeve but his recollection is that he got out on his own. After removing himself from both the coat and the mask he made his way out the front door. There was a door to the outside in the laundry room, however he didn't notice it. He emerged from the building wearing only his bunker pants/boots and a sweatshirt. Something had fallen into one of his boots and was burning him so he quickly got those off as well. He was assisted to a stretcher wearing the sweatshirt, shorts, and ankle socks.

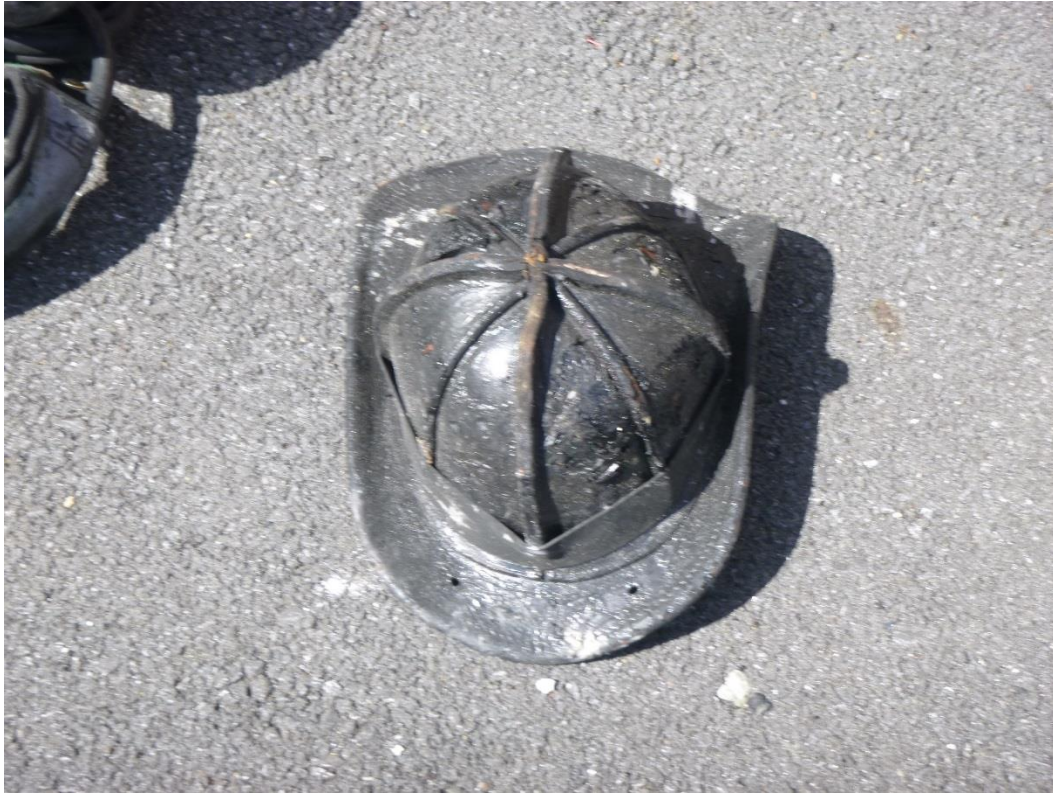
Figure 33-Outside of Helmet

Many of the firefighters on the scene were wearing helmets that do not meet current NFPA standards. Older versions of NFPA standards stated simply that if the object met the standard when it was manufactured, it remained compliant throughout its useful life. In 2008 that was changed for helmets to a 10 year life cycle (NFPA 1581, *Selection, Care and Maintenance of Structural Firefighting Protective Clothing*). The injured firefighter was wearing an old helmet (30+ years) that did not have a chin strap and the helmet fell off shortly after he fell through the floor. It did not have an impact shell. The inner lining and ear flaps were apparently made of combustible material because they burned completely away (See Appendix E).
